BTS BUILDING & CONSULTING Pty Ltd

Pre-Purchase Building Inspection Report

(In accordance with AS4349.1 2007 'Inspection of Buildings')

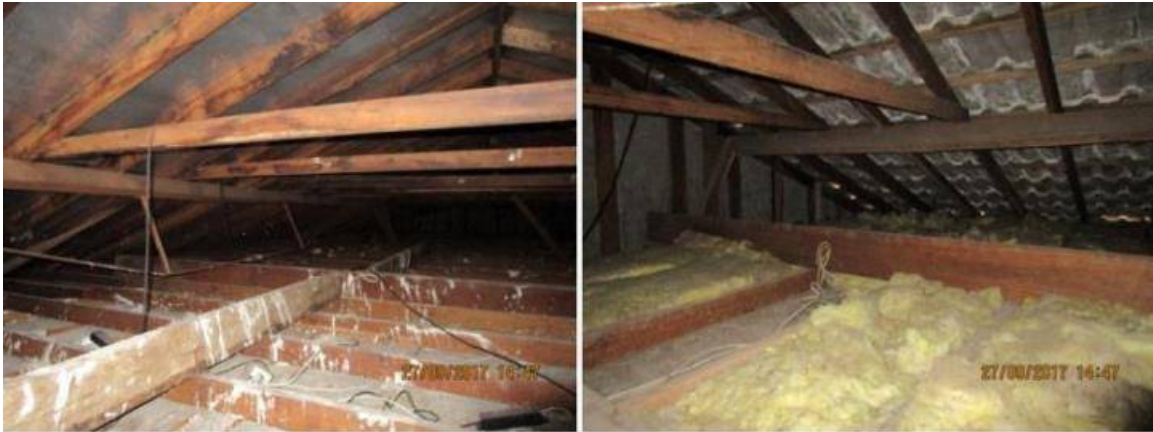
The cut and pitched roof timbers appear to provide adequate support.

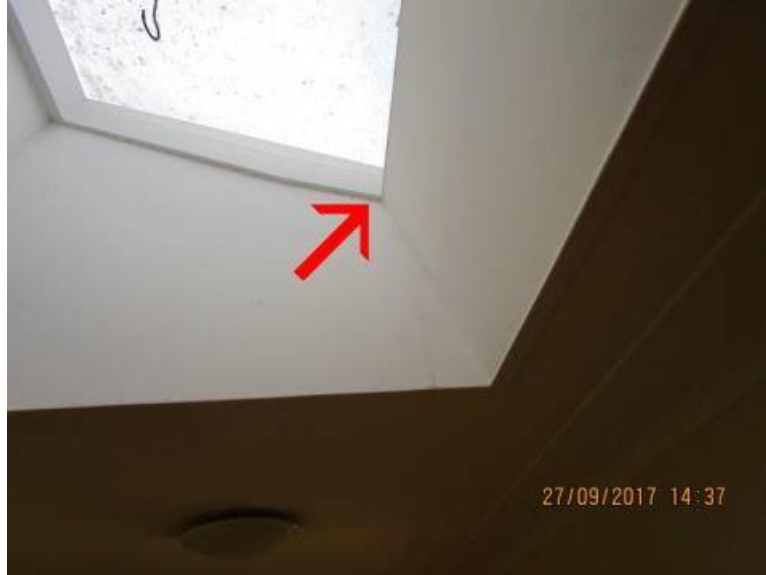
The condition of the ceilings is generally fair. Evidence of current water penetration through ceiling.

A licensed Roofing Contractor should be called to make a further evaluation and repairs or rectification as needed.

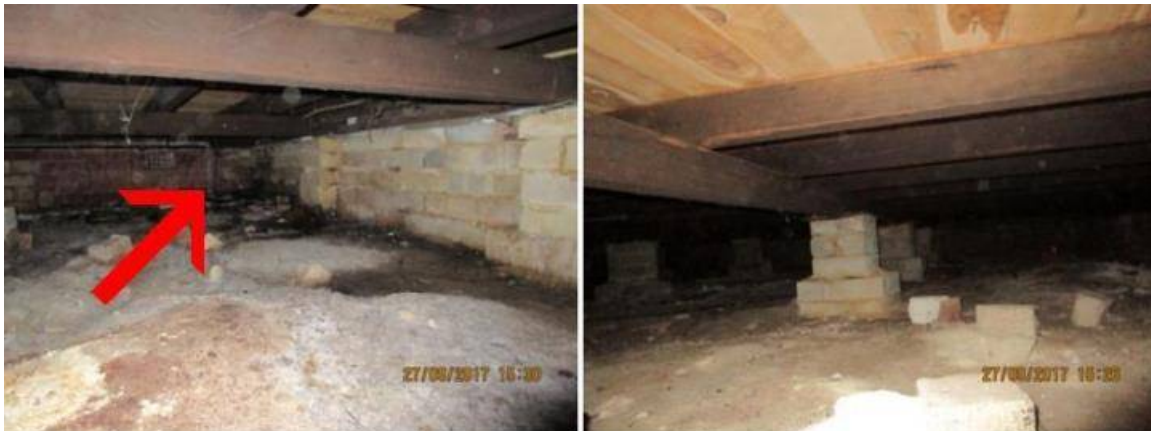
Although antcapping is fitted, it is rusting in some areas. The purpose of antcapping is to prevent concealed termite entry by forcing the termites build mud tunnels around the visible sections of the antcapping enabling detection during a pest inspection. Antcapping will not prevent the entry of termites to a structure however, correctly fitted ant caps will assist in early detection. If it is not possible or practicable to fit or repair antcapping, this area should be regularly inspected by a Licensed Pest Inspector. Deteriorating bricks and mortar joints to the brick piers require repair. Leaks were noted in the water pipes under the bathroom and the pipes should be repaired by a Licensed Plumber. Water is ponding on the ground under the structure. This is considered to be a major defect and should be further investigated and rectified.

A qualified Leak Detection Expert should be engaged for further investigation and diagnosis. A licensed Building Contractor should be called to make a further evaluation and repairs or rectification as needed.
